Journal of Building Engineering

Assessment of seismic load resistance for STPU-strengthened masonry wall structure

Tae-Hee Lee, Jang-Ho Jay Kim *

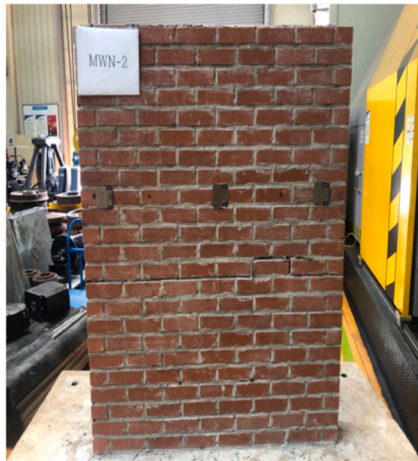
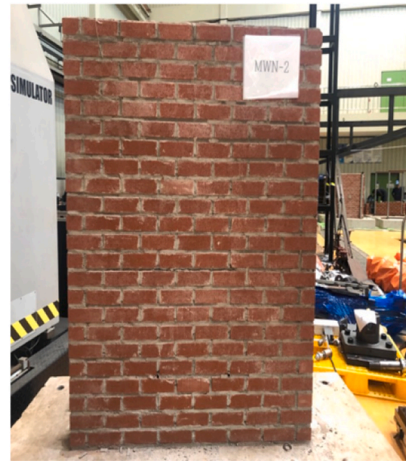
(a) front

(b) the back

(c) sketch of front

(d) sketch of the back

Fig. 8. Crack pattern in MWN-2 specimen.

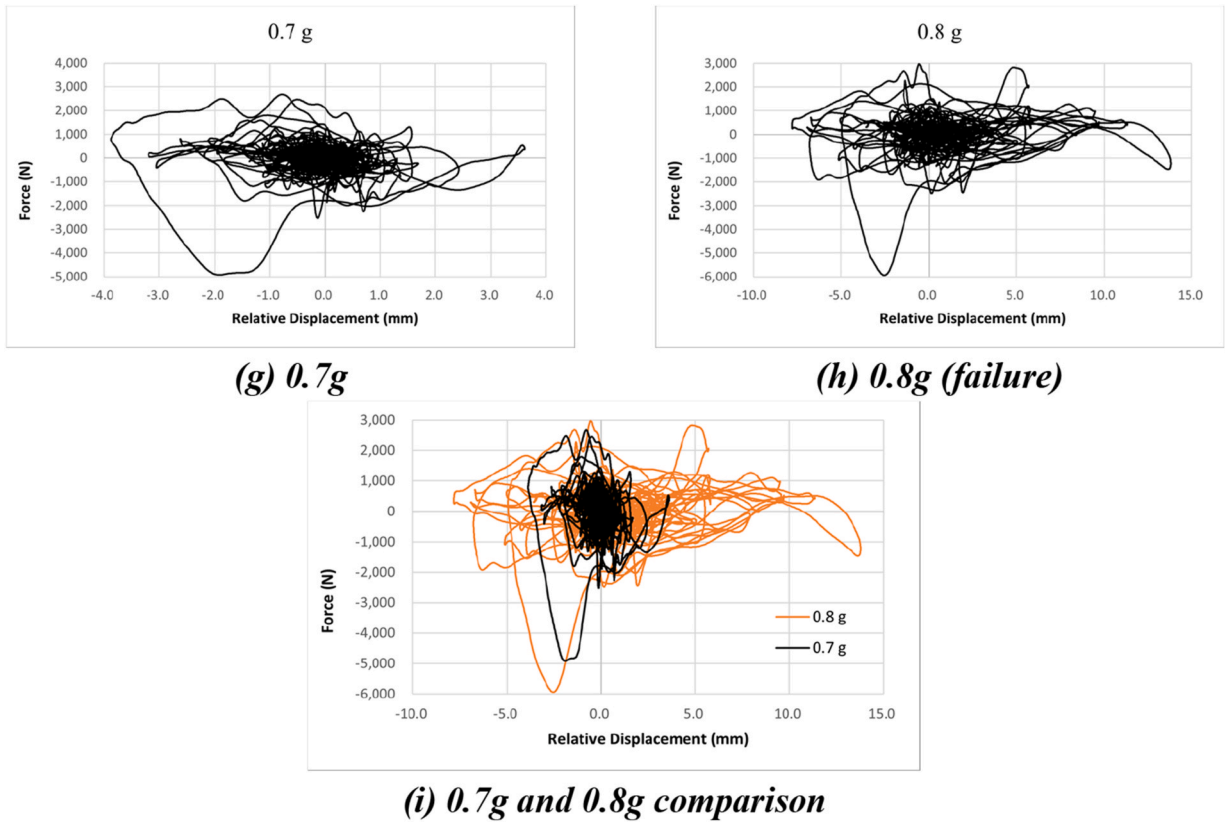
Fig. 21. MWP2-2 specimen hysteretic curves.

The response of the specimens in terms of hysteretic curves behavior was also evaluated. Figs. 20–22 present the hysteretic curves of each specimen. For each type of specimens, the specimen with complete and uninterrupted data collection is used for drawing hysteresis graph. For non-strengthened, STPU strengthened, and GFRP-STPU strengthened specimens, MWN-3, MWP2-2, and MWPF5-

2 data were selected for hysteretic curve presentation. The horizontal axis of each graph represents the relative displacement, which is the difference between the displacement of the specimen’s top and bottom of the wall. The vertical axis represents the force applied to the specimen, derived from the acceleration data (ABK) recorded during the shaking table test.

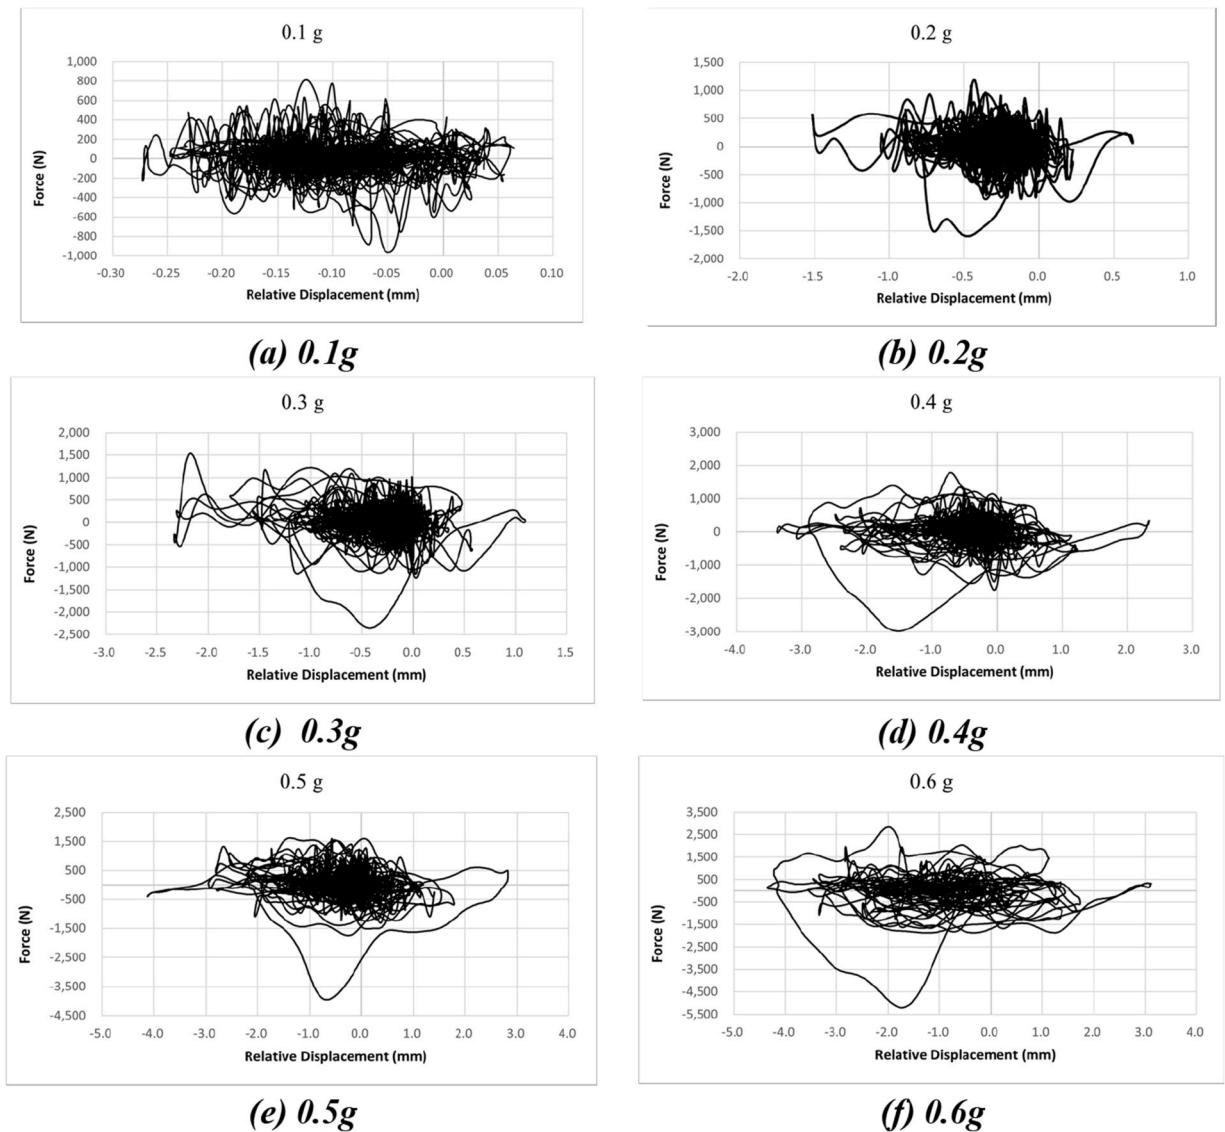
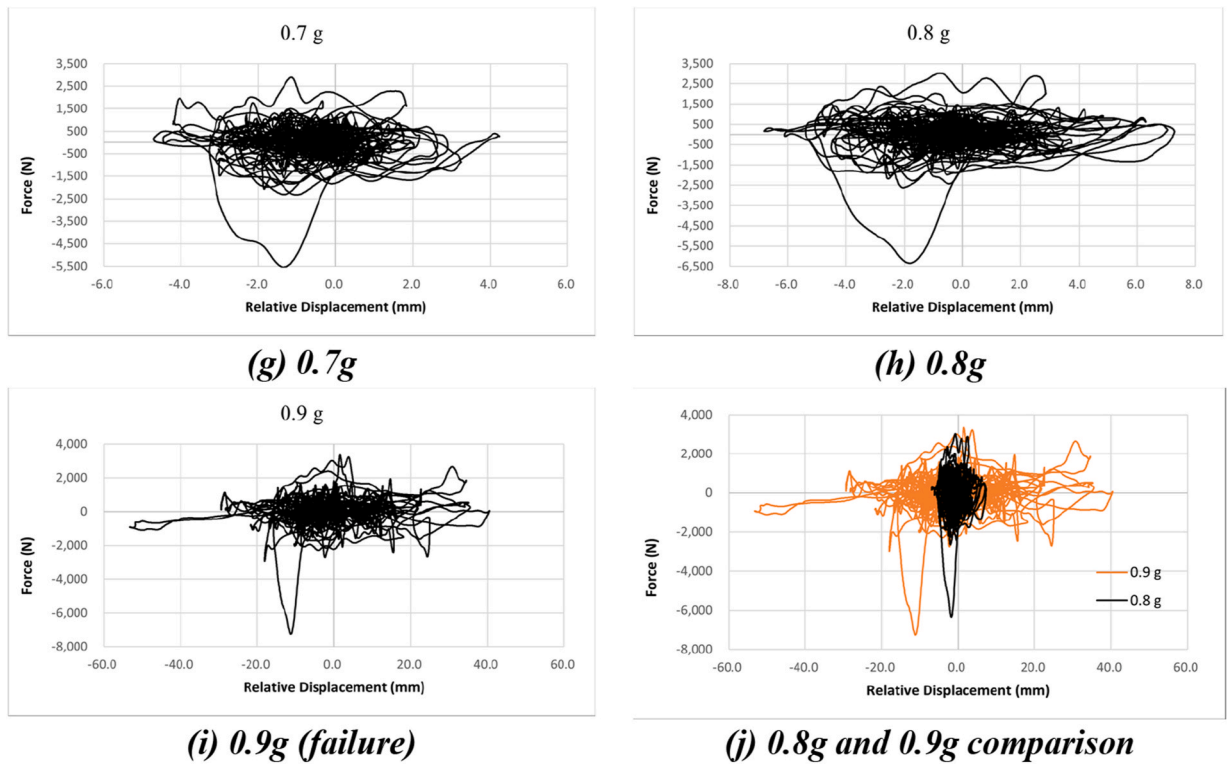
Fig. 22. MWP5-2 specimen hysteretic curves.
